**Flood Control Project Maintenance  
Levee Inspections**

**Fall 2011 Levee Maintenance Deficiency Summary Report**

**California Department of Fish and Game Shea Levee**

**Levee Inspection Report By Mile - Fall 2011**

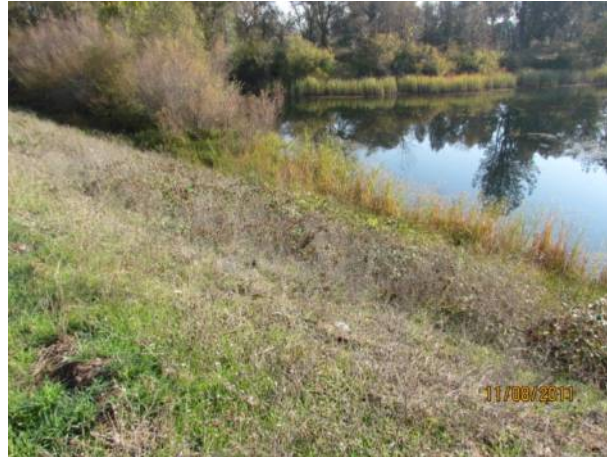
rduffey\_f\_20111128\_541.jpg

Levee Mile Report Line	1
Start Levee Mile	0.02
End Levee Mile	0.06
Location	Land Side
Category	Earthen Levee
Item	Vegetation

View of the berries vine along the L/S slope.

LMR No.	Levee Mile		Category	Item	Location *	Rating **	Action/Comment	GPS Latitude/Longitude		Issue No. Photo
	Start	End						Start	End	
1	0.02	0.06	Earthen Levee	Vegetation	LS	M	Remove the wild growth other than native grasses from the levee slopes.	40.511185 ° -122.360553 °	40.510670 ° -122.361203 °	1 Y
2	0.25	0.30	Earthen Levee	Vegetation	LS	M	Remove the wild growth other than native grasses from the levee slopes.	40.508138 ° -122.363480 °	40.508138 ° -122.363480 °	2 Y

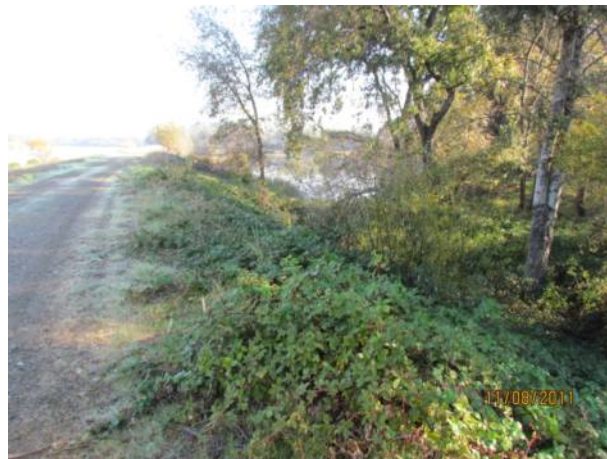
rduffey\_f\_20111128\_542.jpg

Levee Mile Report Line	2
Start Levee Mile	0.25
End Levee Mile	0.30
Location	Land Side
Category	Earthen Levee
Item	Vegetation

View of the vegetation along the L/S slope.
